Will Restoration of Ecological Functions of Tank Cascade System Contribute to Reduce CKDu in Sri Lanka? A review

Abstract

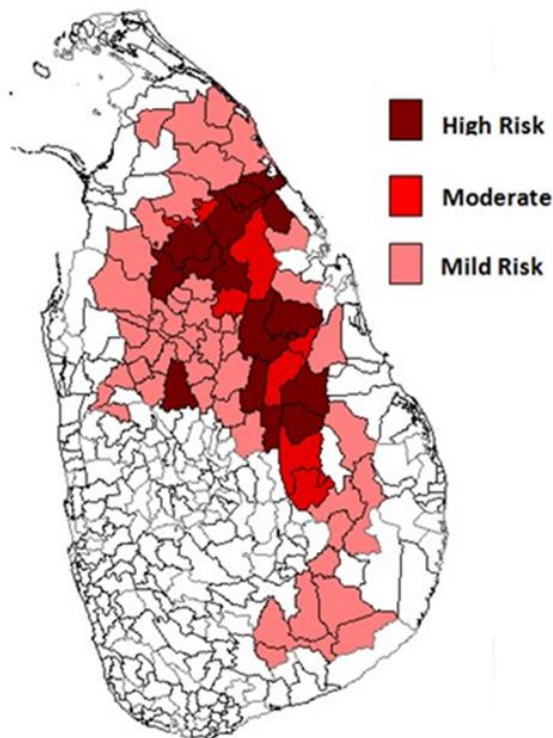
Figure 1. Registered CKDu patients upto December 2014 (adopted from <http://www.presidentialtaskforce.gov.lk/en/kidney.html#>)

Figure 1 shows the divisional secretariat level distribution of CKDu patients in Sri Lanka while figure 2 exhibits the distribution of small tanks in Sri Lanka. We noted that the CKDu patient spatial distribution is approximately similar to those of tank spatial distribution. There are no reports indicating that the CKDu prevailed and significant death tall occurred during history in these regions. Instead, there are reports for the malaria infestation in recent past. That is also partially attributed to abundance of small tanks in the area. Therefore, we believe that the adverse changes that took place to the ecosystem of the tank cascade system or *ellangawa* (Sinhala folkloristic term) and new commercial practices of agriculture of dry and intermediate zone of the country have also become reasons for the spreading of CKDu.

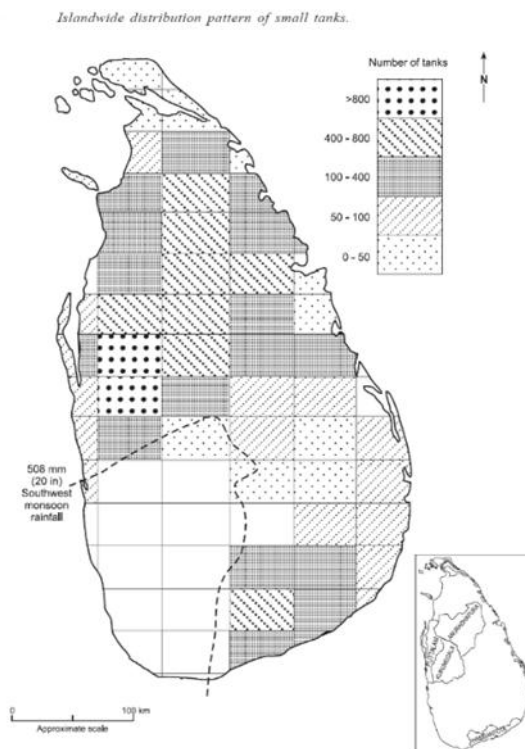
Figure 2. Island wide distribution of small tanks in Sri Lanka (adopted from Panabokke *et al.*, 2002)

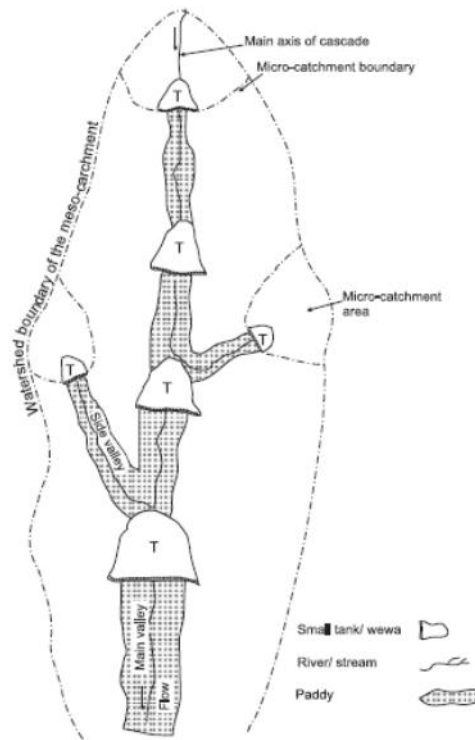
Figure 3. Schematic representation of small tank cascade system of Sri Lanka (adapted from Panabokke *et al.*, 2002)

Iswetiya or *Potawetiya* is an up stream soil ridge made at either side of the tank bund to avoid sediment particles entering from upper land slopes towards the tank (Figure 3). In addition, *Godawala* and *Kuluwewa* were constructed to trap sediments reaching from the ephemeral stream to the tank. *Godawala* which is found in association with a small tank, is a manmade waterhole. Whereas *Kuluwewa* a small tank or pond above large reservoirs trap sediments and provide water for cattle and wild animals which may be a strategy to avoid man-animal conflicts (Figure 3). Construction of these *Iswetiya* or *Potawetiya*, *Godawala* or *Kuluwewa* ensures the good water quality and arrest siltation of the tank. In addition, villagers used to remove sediments from most silted areas of the tank bed during extended dry spells usually at a frequency of 3 to 5 seasons. This sediment removal (de-siltation) process (*Kattikapeema* in Sinhala folkloristic term) has been considered as a common responsibility of the downstream water users and carried out through community volunteer work. However, de-siltation process was restricted only to well-identified locations of the tank bed and a sediments layer of not more than 15cm deep and the materials removed from the tank bed was not placed on the dam (Dalupota, 2005). Further, early engineers constructed mud sluice to remove the silt emptying the tank. Moreover, the place of the spillway of tank is generally designed to open to a low rock outcrop area (Panabokke et al., 2002) so that erosion is minimized from the water released from the tank. Hence, tank water was sustainably used for drinking, bathing, washing and irrigation. Raising the dam or spill was not required as at present to accommodate a sufficient quantity of water for irrigation.

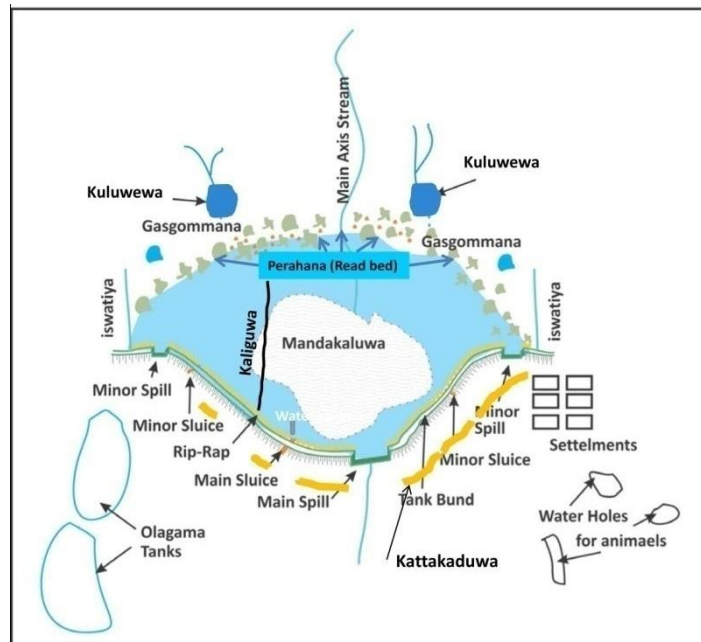
Figure 4. Components of a village tank and their relative positions in the small tank village in Sri Lanka (adapted from Tennakoon, 2015a)

Tanks/ *Wewa* consists of some remarkable bio-engineering structures in order to conserve the soil, control water flow and purifying water. Schematic representation of components of small tank (Tennakoon, 2015) is shown in figure 4 while we try to show the tank profile and its components using figure 5. Proper functioning of these components, the earthen dam (*We-kanda*), sluice gates (*Sorrowwa*), spillways (*Pita Wana*), valve pit (*BissoKotuwa*), *iswetiya* (upstream conservation land), *gasgommana* (upstream wind barrier made of tree plantations), *kattakaduwa* (downstream wind barrier, located in between the sluice and paddy), *tisbamme* (land strip around the hamlet for protection), *Thaulla* (upper peripheral gentle sloping land) and *wew ismaththa* (closer catchment) ensure the better quality, quantity and sustainability of the water for the tank/*wewa*. Table 1 summarizes the functions of different components of the tank in relation to water quality improvements while figure 6 shows the successions of water quality improvements in a small tank system as a whole.

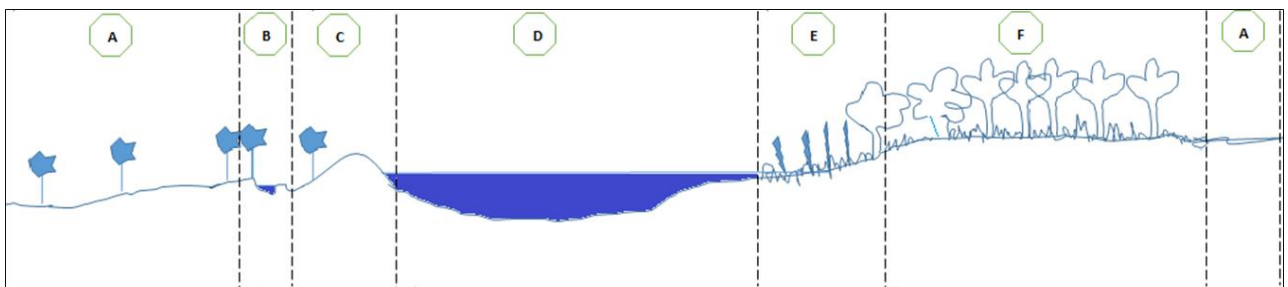
Figure 5. Schematic representation of the profile of small tank and its components (Produced by the Authors)

A : Command area specially paddy ; B : Kattakaduwa; C: Earthen Dam ; D: Water spread area of the tank; E: Thaula ; F: Closer catchment/ Wew Ismaththa

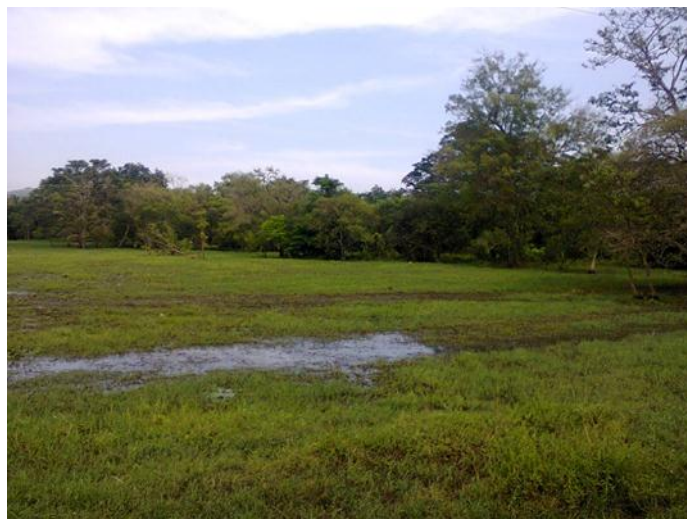
Figure 7. *Thaulla* area of ulankulama tank, Anuradhapura in Sri Lanka (Produce by the Authors)
